# Manhole Inspection Summary

Manhole # S49AA\_048MH

Insp Date: **5/8/08 9:13 AM**

**Location** Address: **rear 535 n glover st**

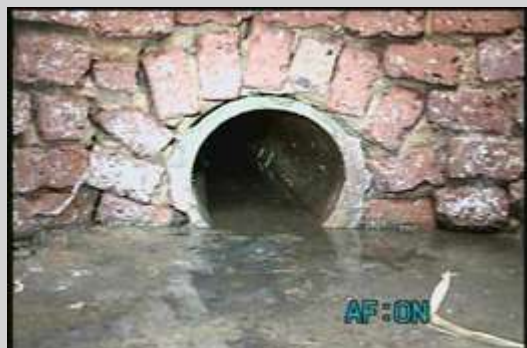
12 O'Clock Outflow

8 in. Circular Gravity Sewer  
Pipe Out @ 12 O'Clock

Infiltration: **None** Pipe Seal Cond: **Unknown**
